RE: Inspection Topaz Mountain Mine, Brush Wellman, M/023/003, Juab, Utah

Date of Inspection: June 25, 1992  
Time of Inspection: 2:00 p.m. - 5:00 p.m.  
Conditions: Cloudy and warm  
Participants: Cristina Reed, BLM; John Wagner, Brush Wellman; Holland Shepherd, DOGM

## Pits, Dumps, & Roads Reclamation Map

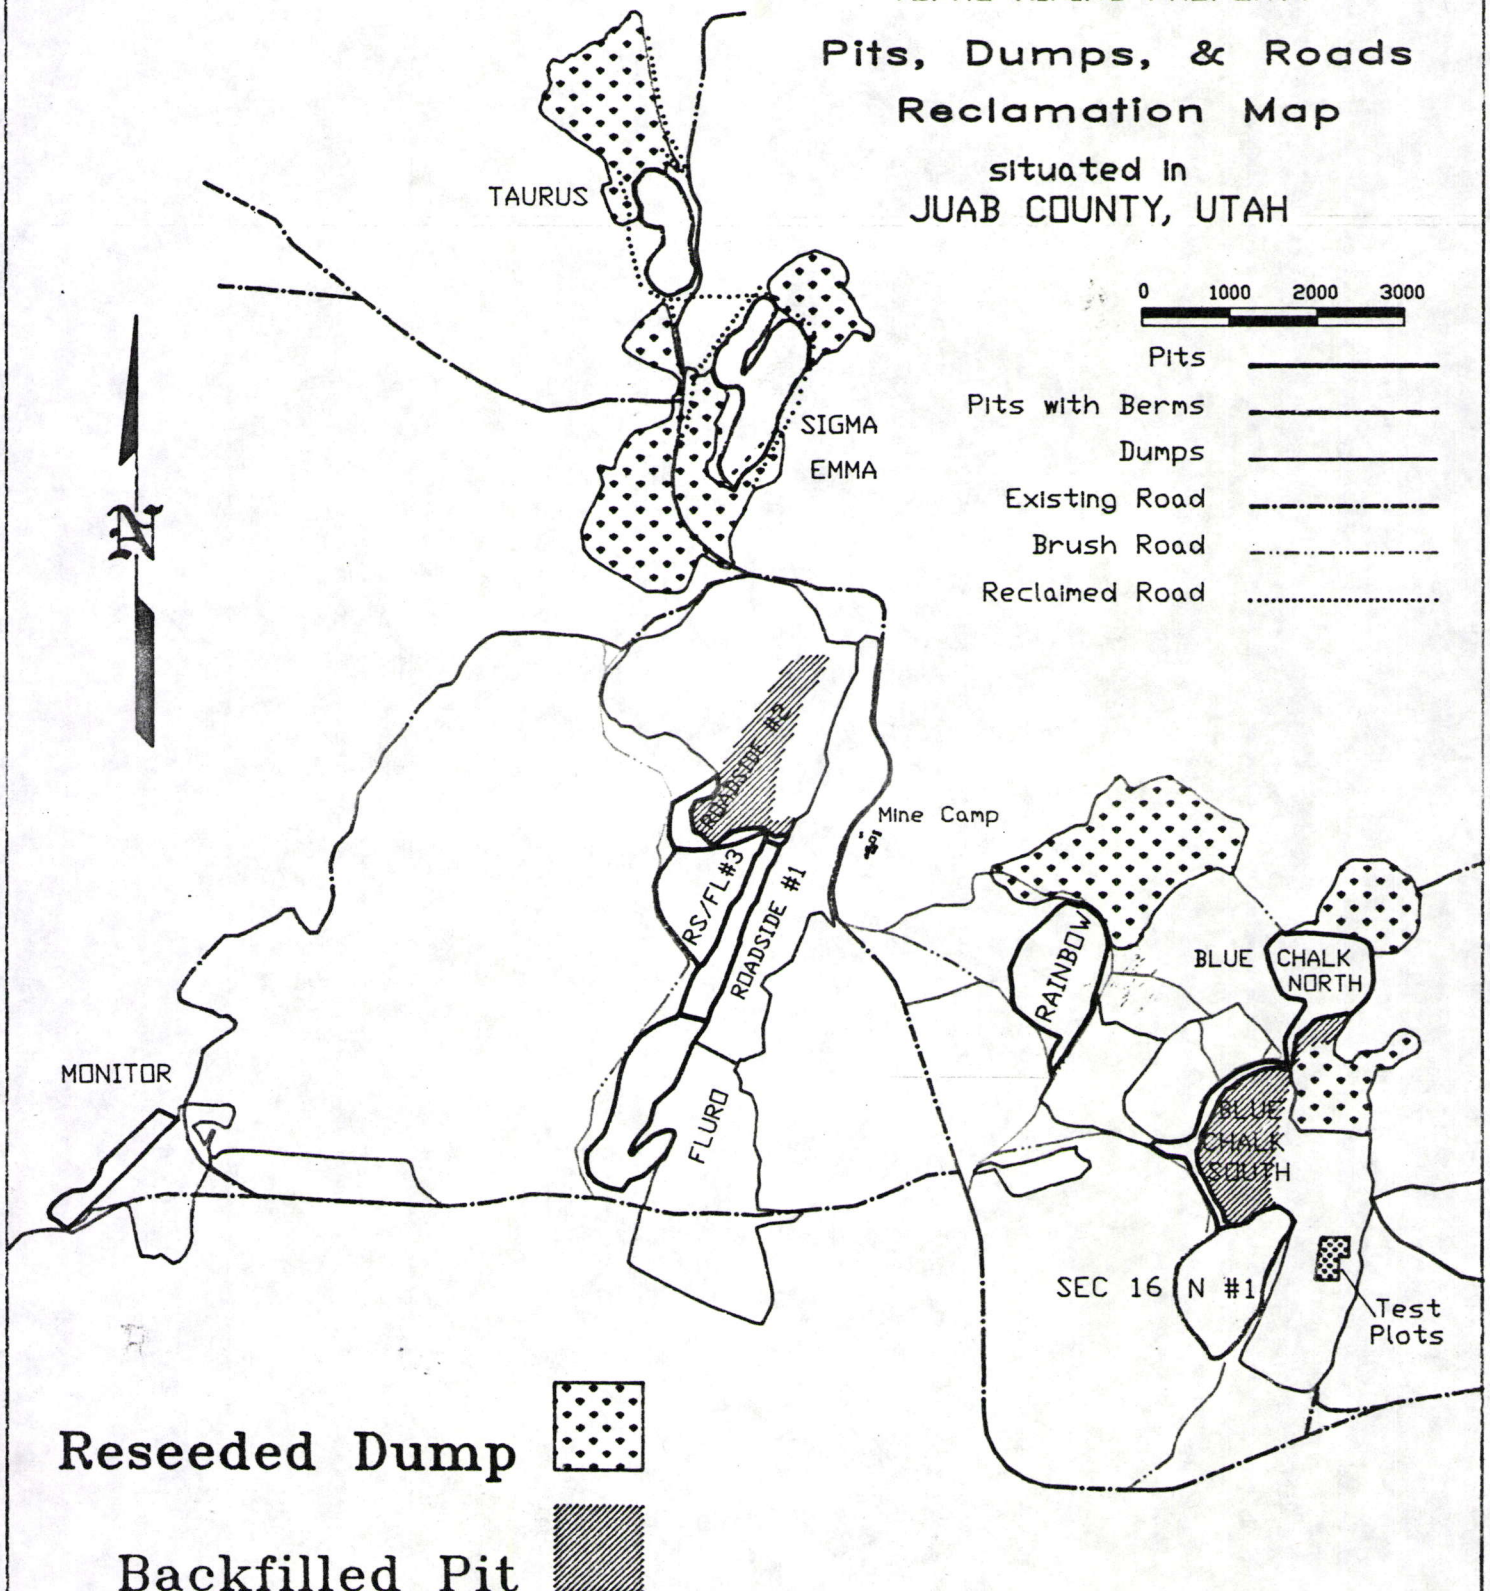
First portion of the inspection involved a look at the test plots installed last fall. The plots are located by the Section 16 Dump site, and encompass @3 acres of site (see attached map). The operator has clearly described these plots and the seedmix, in the 1991 Annual Report. The site maintains less than a years worth of growth, so it is to soon to make a determination concerning plant success.
